#### **SUMMARY**

1234 Main Street Somerville TN 38068 Buyer Name 10/13/2022 9:00AM

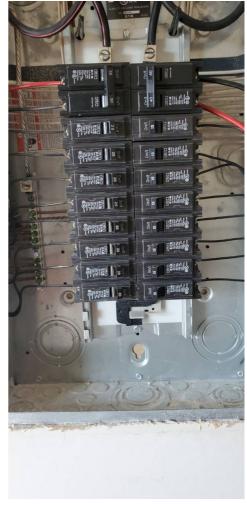
9.7.1 AFCIs

#### **MISSING AFCI**

I observed indications that an AFCI is missing in an area that is required to keep the house safe.

Recommendation Contact a qualified electrical contractor.

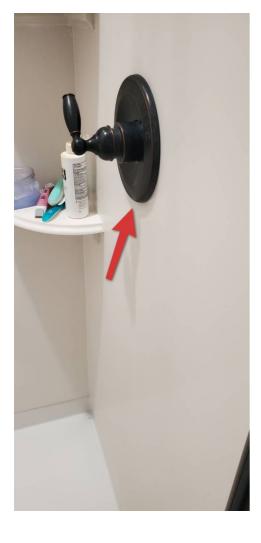
11.2.1 Sinks, Tubs & Showers

#### **LOOSE FIXTURE**

I observed indications that the fixture is loose. Not secure. Not installed properly. Loose.

Recommendation

Contact a qualified plumbing contractor.

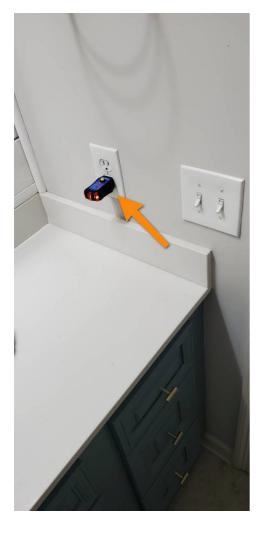
### 11.4.1 GFCI & Electric in Bathroom GFCI NOT TESTING AS FUNCTIONAL

**GUEST BATHROOM**

I observed a defect at the GFCI in the bathroom. It was not testing properly. Not functioning.

Recommendation Contact a qualified electrical contractor.

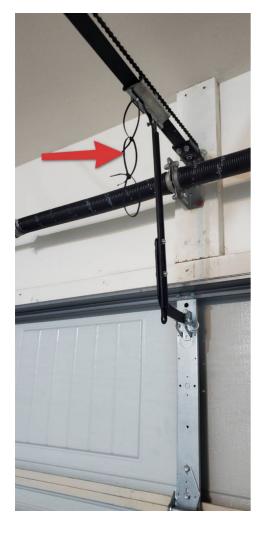
## 14.3.1 Garage Vehicle Door Opener MANUAL RELEASE NOT RED

I observed that the manual release handle of the garage door opener was not colored red so that it can be seen easily. Defect.

Recommendation Contact a qualified garage door contractor.

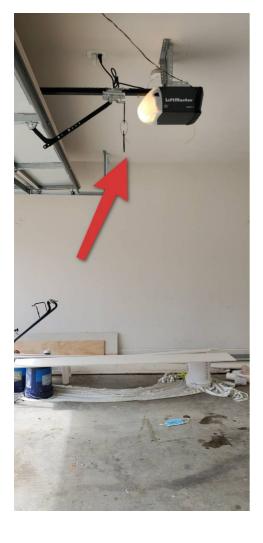
## 14.3.2 Garage Vehicle Door Opener MANUAL RELEASE NOT ACCESSIBLE

I observed that the handle of the manual release was not easily accessible and more than 6 feet above the garage floor. Defect.

Recommendation Contact a qualified garage door contractor.
